# Updated Status of Fukushima Daiichi Nuclear Power Station

～Regulation, Overview, Actions～

Director, Nuclear Regulation Division for BWR  
Nuclear Regulation Authority (NRA), Japan

September 2013

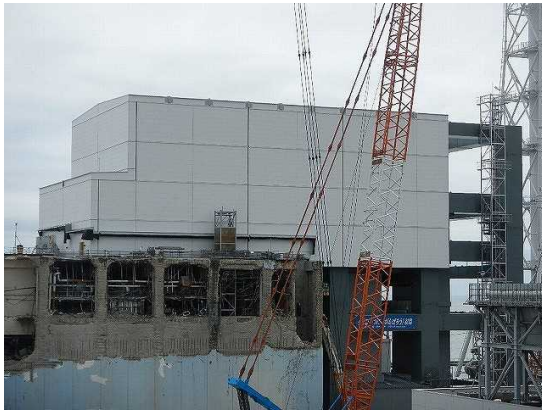
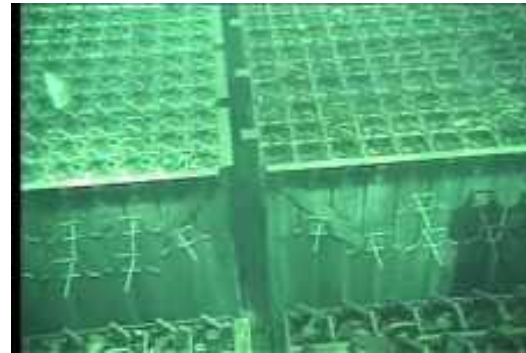
- ✓ Fuel Rack and Assembly of SFP of Unit4 had little damage.
- ✓ Removal of Spent Fuel in Unit4 will be started from November, 2013.
- ✓ Debris over SFP of Unit3 are being removed.

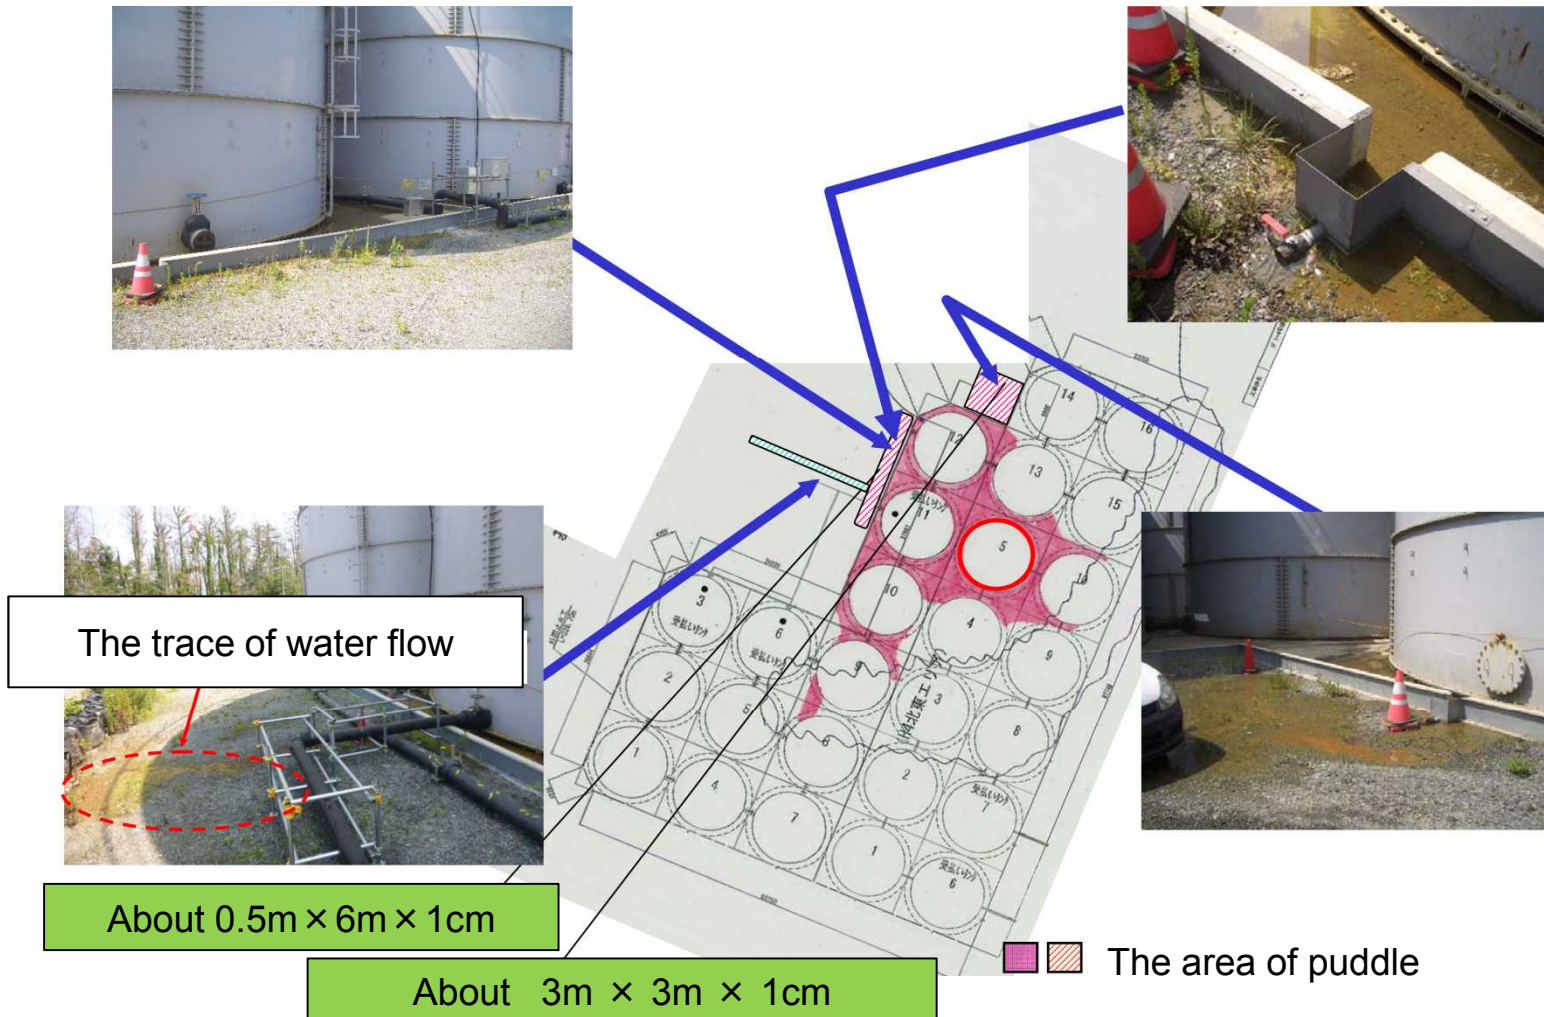
# Leakage of $\beta$ and low-level Cs Water from Cylindrical Tank(1)

✓ Puddle and Trace of Water flow with  $\beta$  were found by TEPCO(August 19, 2013)

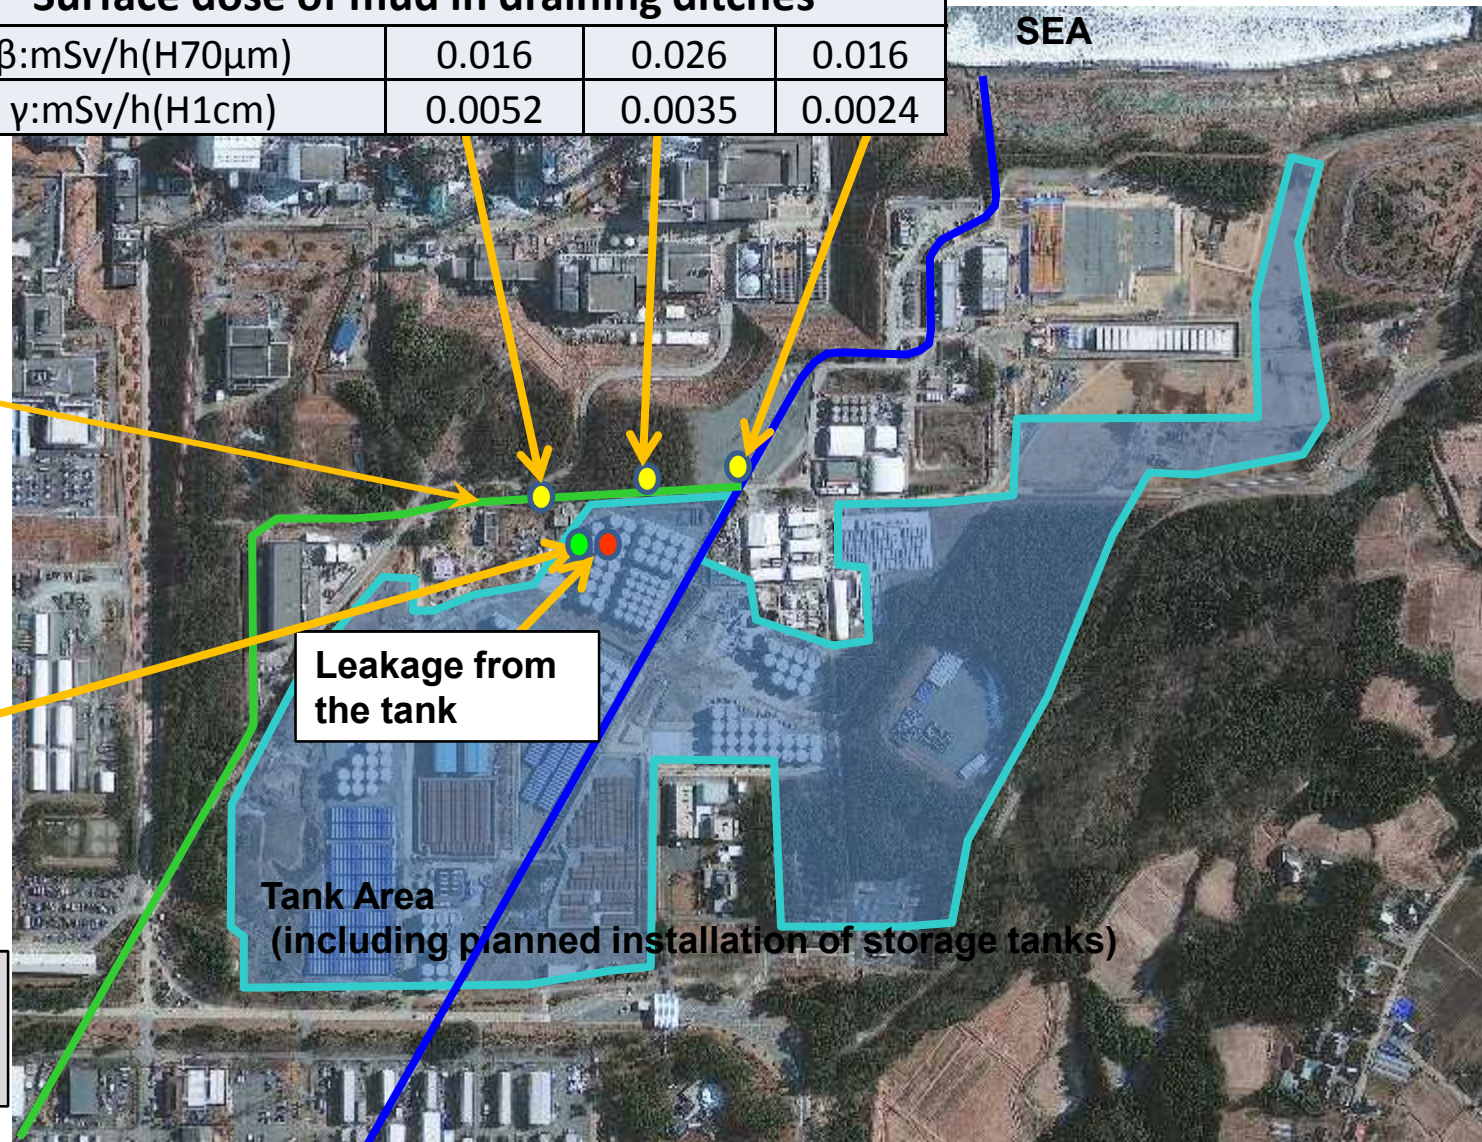
**Sampling Well**  
 • 15m from the Leakage point  
 • 7m of depth

**Ground water**  
 Total  $\beta$  : 2,000Bq/L  
 $^3\text{H}$ :64,000Bq/L

**Leakage from the tank**

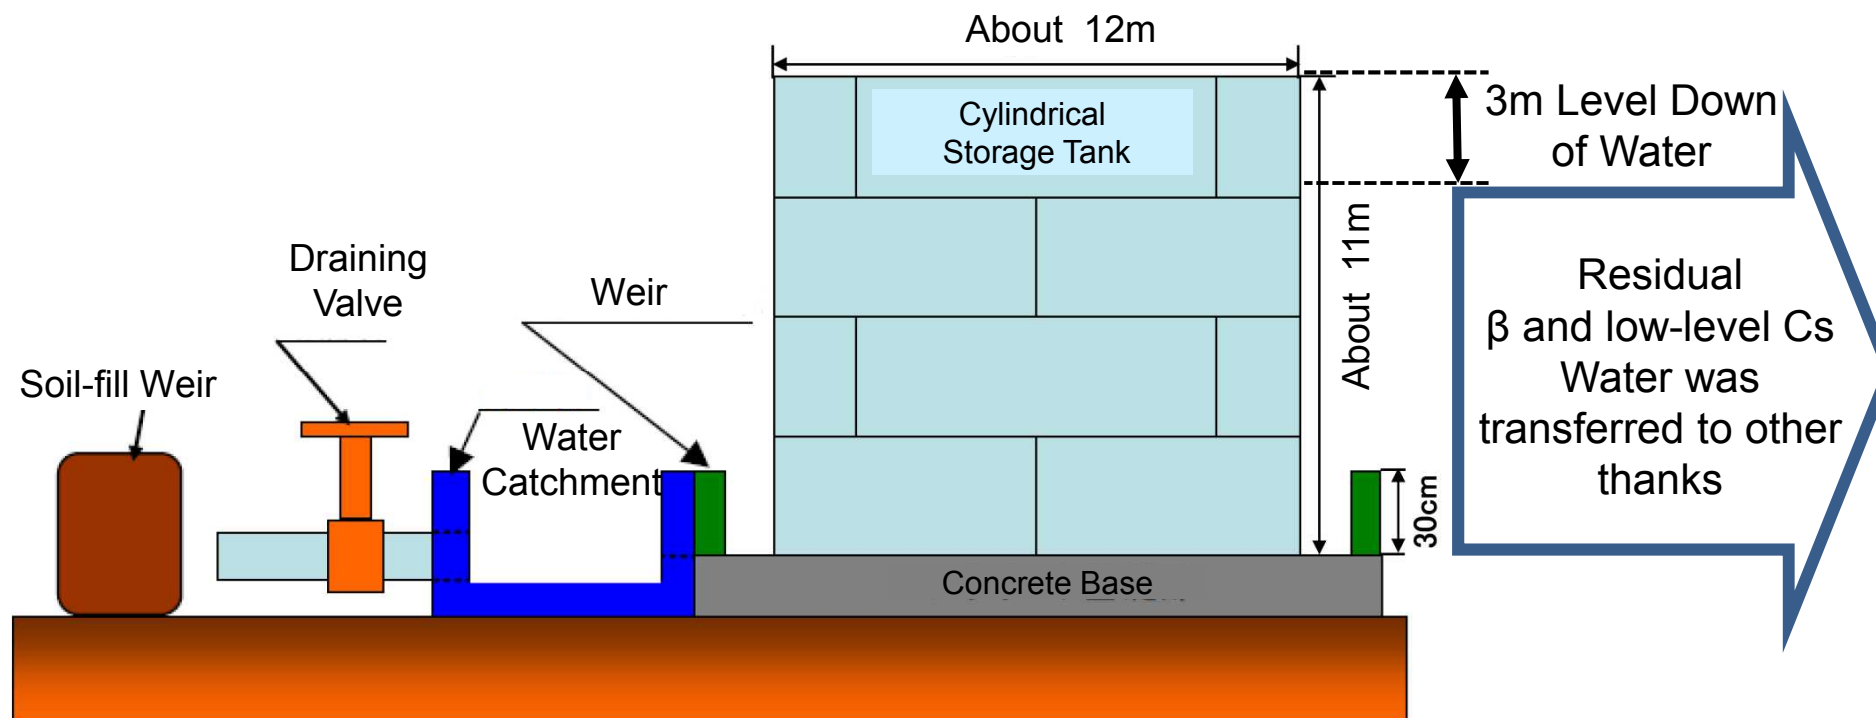
# Leakage of $\beta$ and low-level Cs Water from Cylindrical Tank(3)

## Causes

- ✓ Leakage from flange
- ✓ Normal open of draining valves
- ✓ Delay of detection
  - No water level device
  - Poor patrolling : 2men for 900 tanks/day

## INES Level 3 [Tentative]

- ✓ Amount of Leaked  $\beta$  and low-level Cs Water [Provisional]

$$\begin{aligned}
 &^{137}\text{Cs } 1.0 \times 10^2 \text{ Bq/cm}^3 \\
 &^{134}\text{Cs } 4.6 \times 10^1 \text{ Bq/cm}^3 \times 300\text{m}^3 > \text{A few thousand TBq } ^{99}\text{Mo} \\
 &\text{Total } \beta \text{ } 8.0 \times 10^4 \text{ Bq/cm}^3
 \end{aligned}$$

- ✓ No remaining safety layer

- Facilitation to replace the flange-type storage tanks with welding-type of tanks.
- Early detection of leakage.

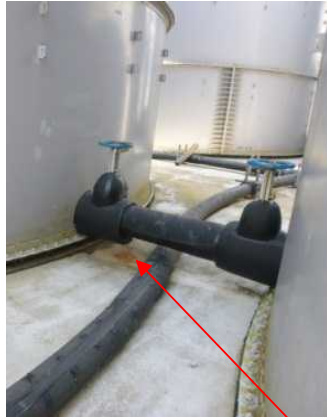
Place of color change

## H5 Area

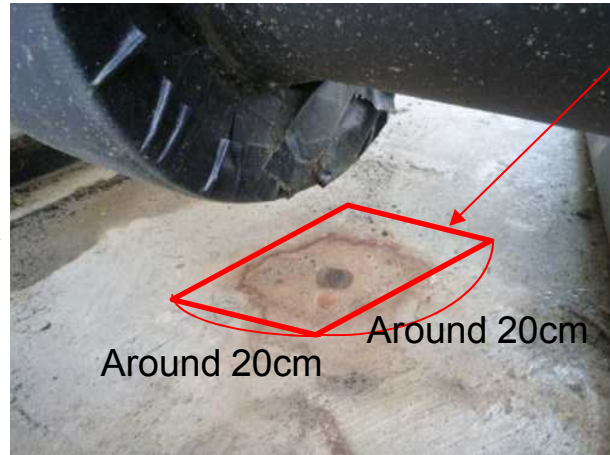
### Puddle trace (20 cm x 20 cm)

At the point 5cm from the surface of the puddle trace 230 mSv/h \* of  $\beta$  rays was detected by TEPCO on 31 August.

It was found by TEPCO that one drop of water fell every 90 seconds after the cover stuff of the flange was removed, and then this water drop has stopped by TEPCO's tightening up the bolts of flange on 1 September.

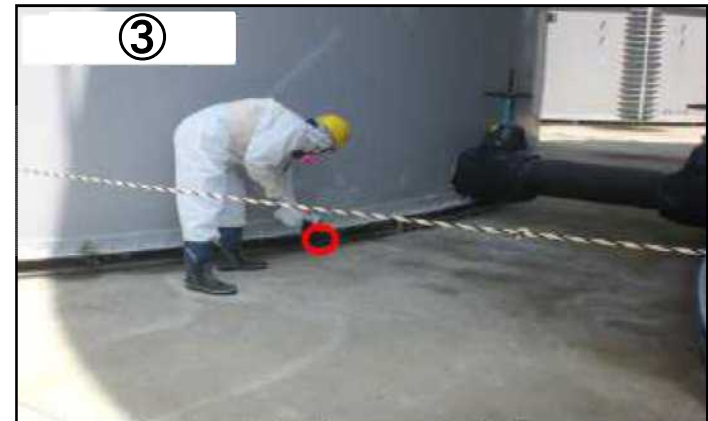
## H3 Area

- ① At the point 5cm from the flange, 220m Sv/h \* of  $\beta$  rays was detected by TEPCO on 31 August.  
**No water leakage was found around here.**
- ② At the point 5cm from the flange, 2200 mS/h \* of  $\beta$  rays was detected by TEPCO on 3 September.  
**No water leakage was found around here.**
- ③ At the point 5cm from the flange, 1800 mSv/h \* of  $\beta$  rays was detected by TEPCO on 31 August.  
**No water leakage was found around here.**
