# Updated Status of Fukushima Daiichi Nuclear Power Station

～Regulation, Overview, Actions～

Director, Nuclear Regulation Division for BWR  
Nuclear Regulation Authority (NRA), Japan

September 2013

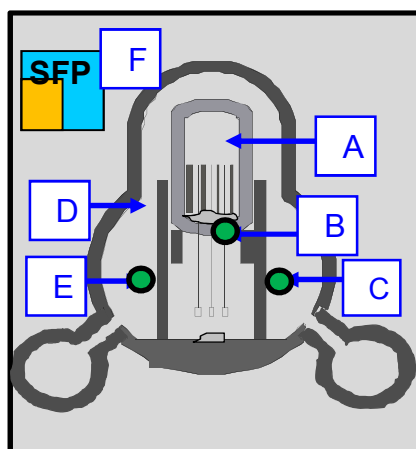
- ✓ Molten cores in RPV and PCV, and spent fuels in SFP have been cooled.
- ✓ H<sub>2</sub> concentration in PCV have been much lower than flammability limit.

Unit 5 & 6 are cold shutdown.

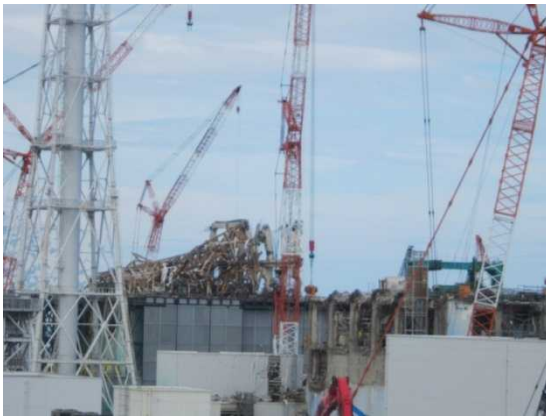
**Unit 3**

- ✓ Fuel Rack and Assembly of SFP of Unit4 had little damage.
- ✓ Removal of Spent Fuel in Unit4 will be started from November, 2013.
- ✓ Debris over SFP of Unit3 are being removed.

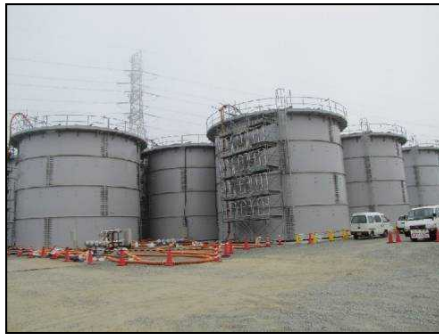
Cylindrical storage tanks

- ✓ 340,000 m<sup>3</sup> of various levels of contaminated water is stored in the storage tanks.
- ✓ 280,000 m<sup>3</sup> out of total volume is  $\beta$  and low-level Cs water that was treated with reverse osmosis(RO) membrane. It is stored in steel-made cylindrical storage tanks with flange.[Sep.3]

- Facilitation to replace the flange-type storage tanks with welding-type of tanks.
- Early detection of leakage.

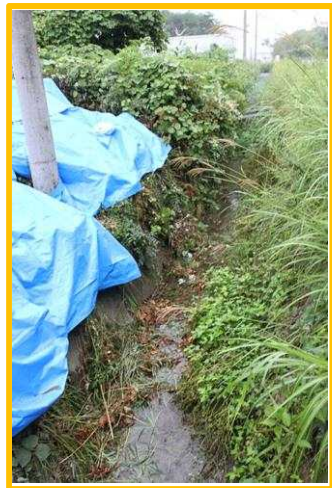
Draining Ditches

Surface dose of mud in draining ditches			
$\beta$ :mSv/h(H70 $\mu$ m)	0.016	0.026	0.016
$\gamma$ :mSv/h(H1cm)	0.0052	0.0035	0.0024

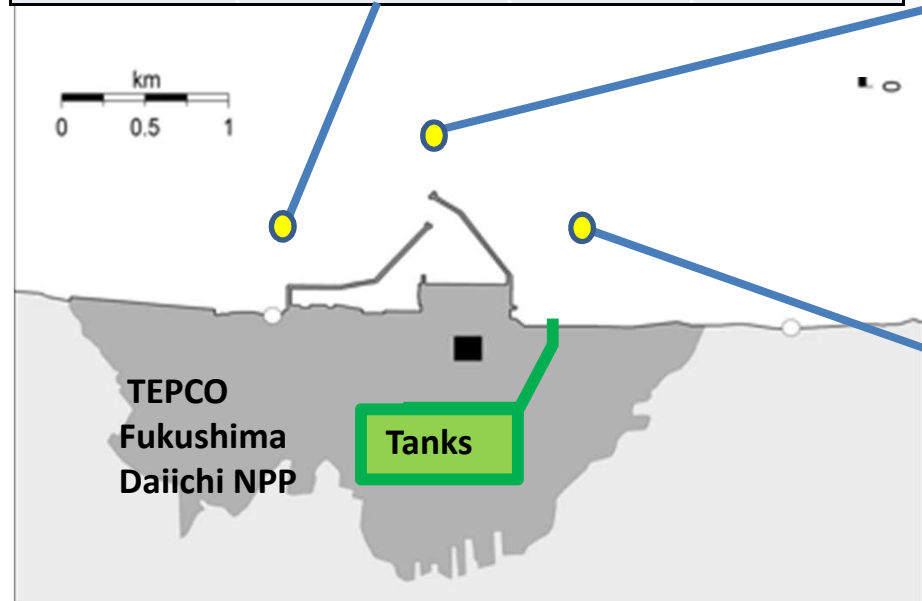
- ✓ Most of all sampled seawater near Fukushima Daiichi NPS were under the detection limits.
- ✓ No change was observed before and after the leakage from Cylindrical Storage Tanks.

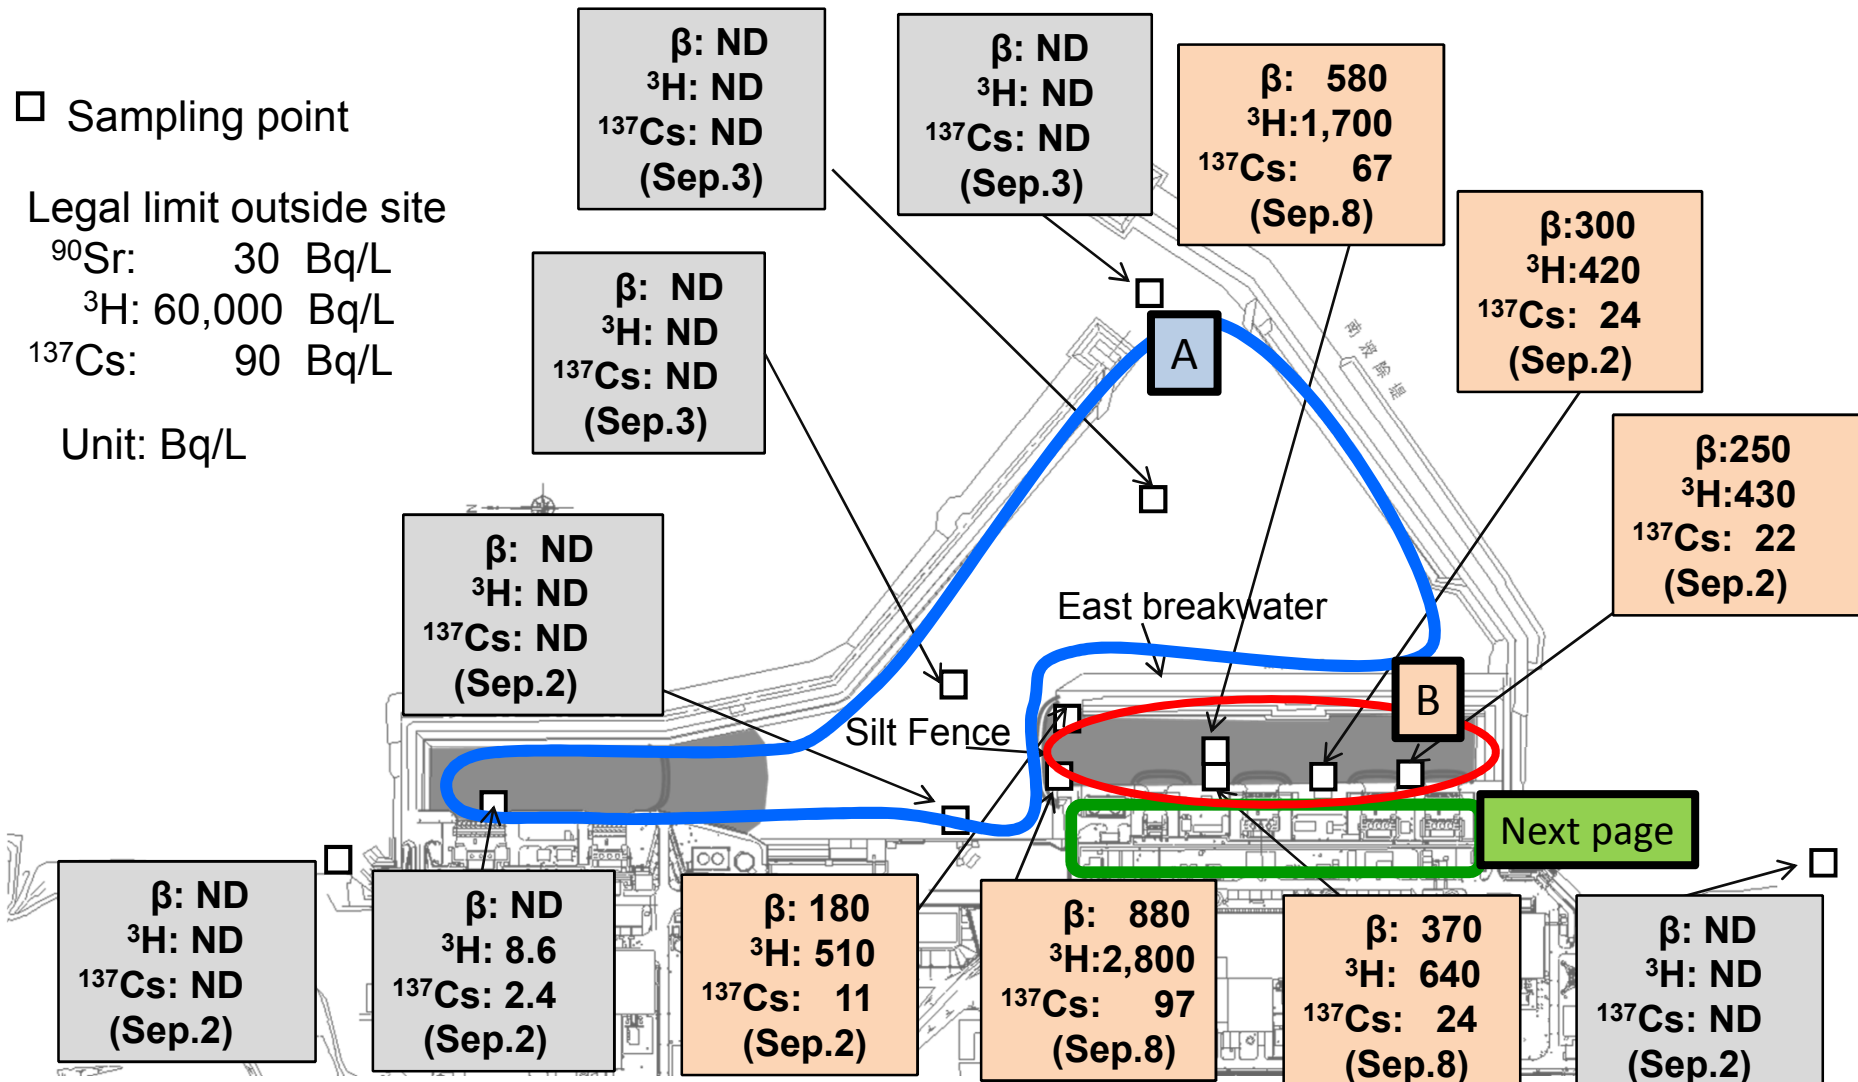
- ✓ Area A, within harbor and outside silt fence and East breakwater: under Legal limit.
- ✓ Area B, within slit fence and East breakwater: over Legal limit.

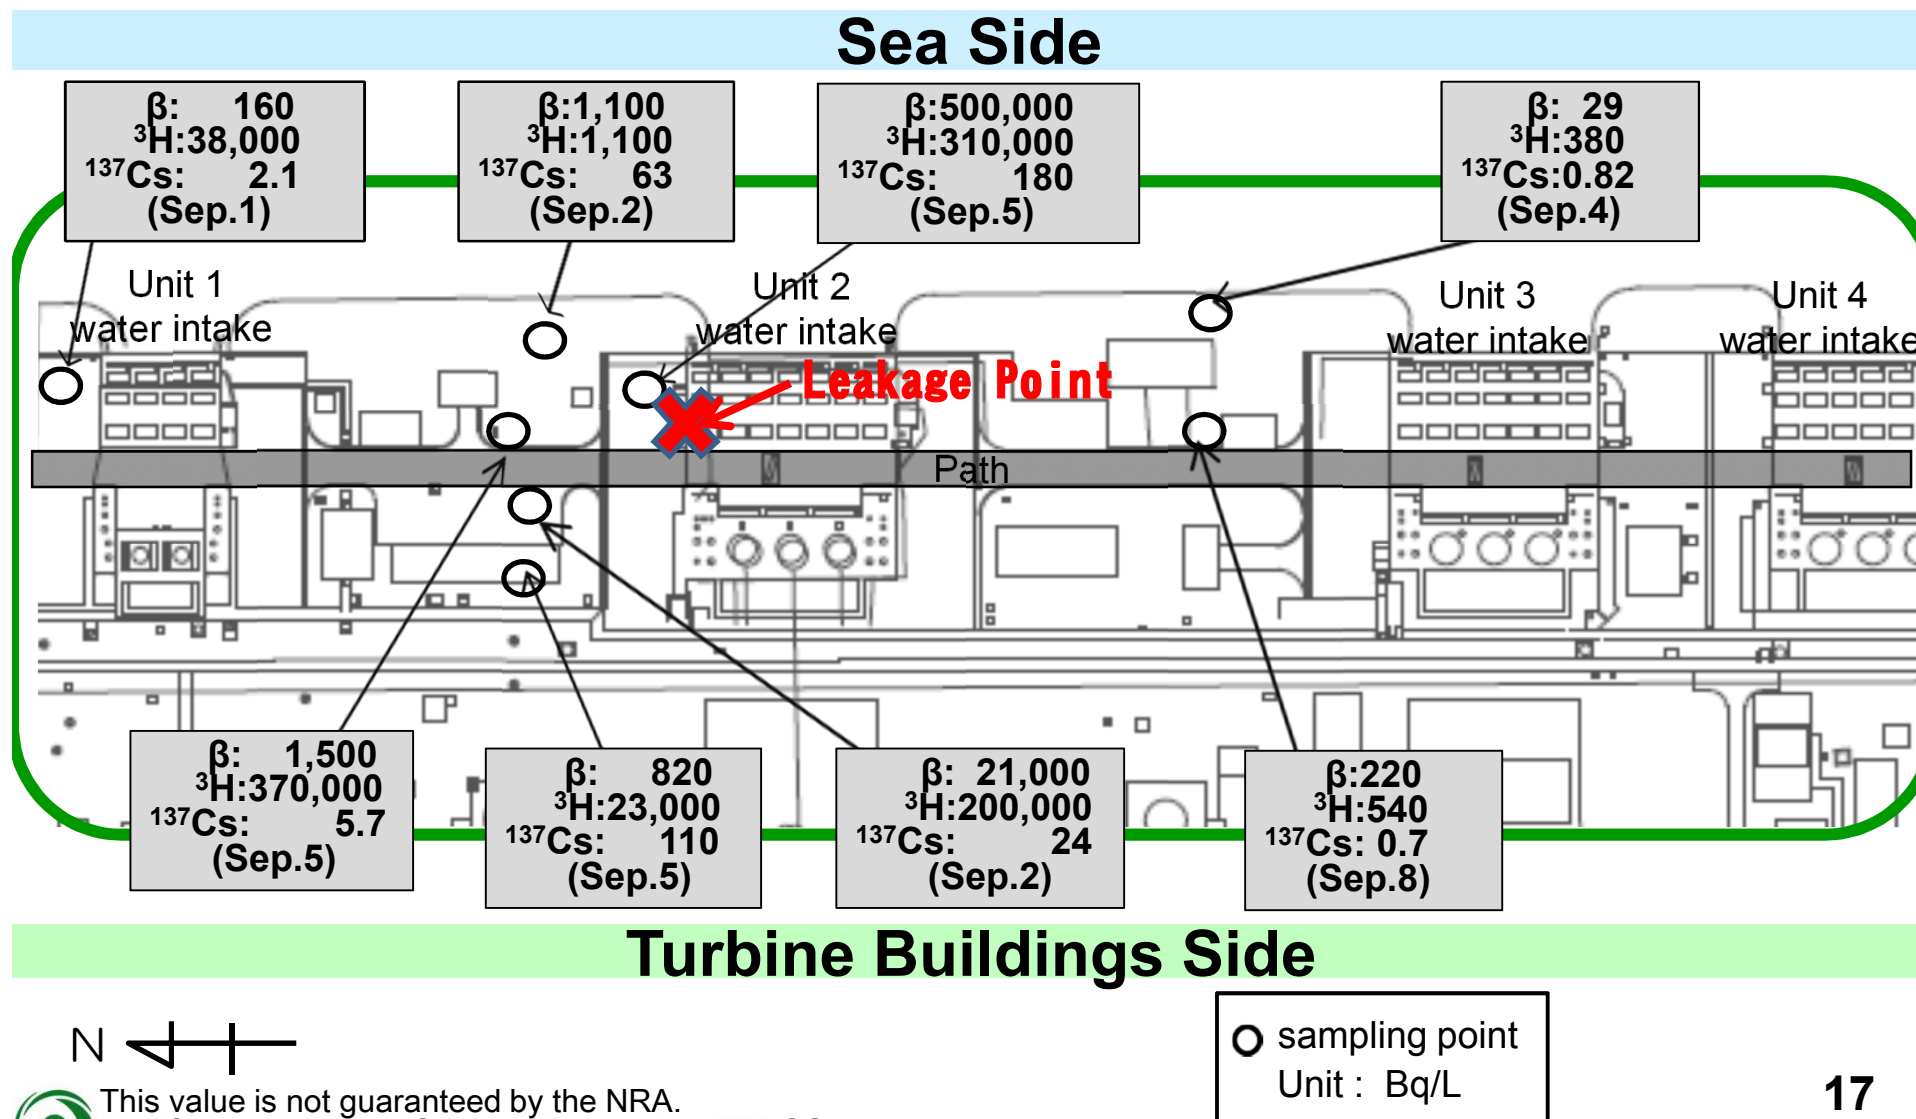
- ✓ High Contamination in Groundwater was found near the Leakage Point on April 2, 2011.
- ✓ Groundwater with  $^3\text{H}$  were also found.

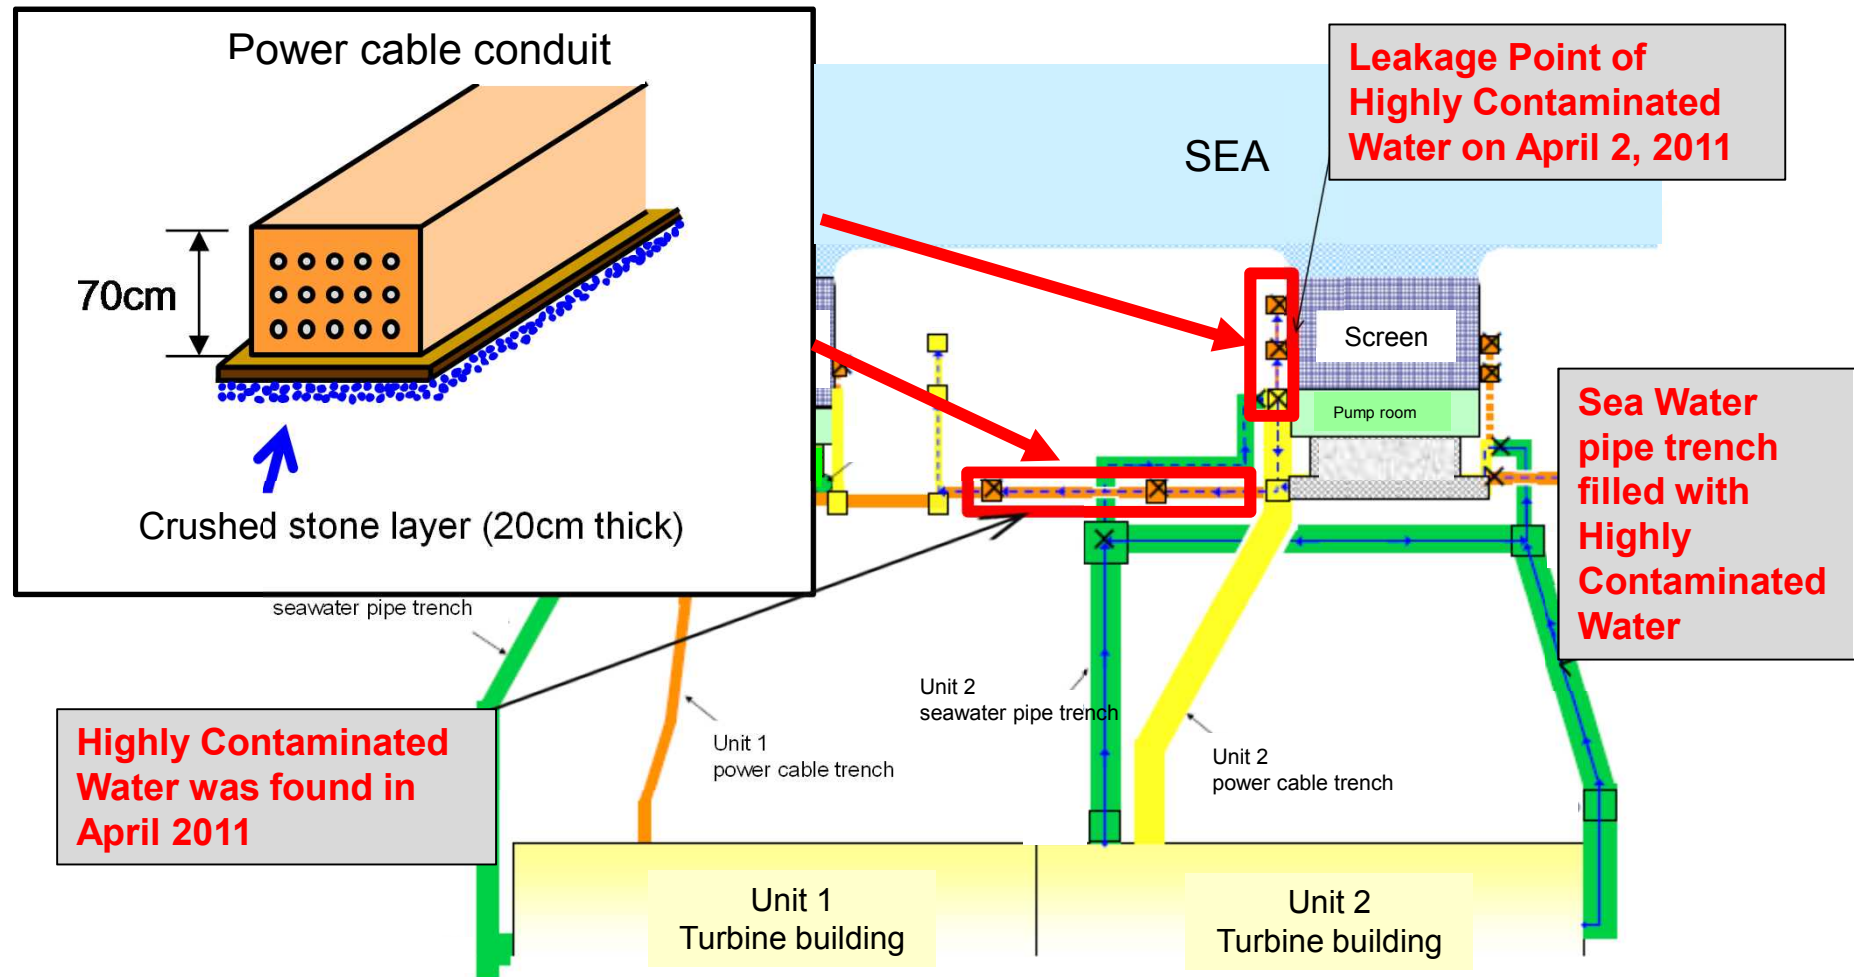
✓ Highly Contaminated Water was estimated to move through the crushed stone layer.

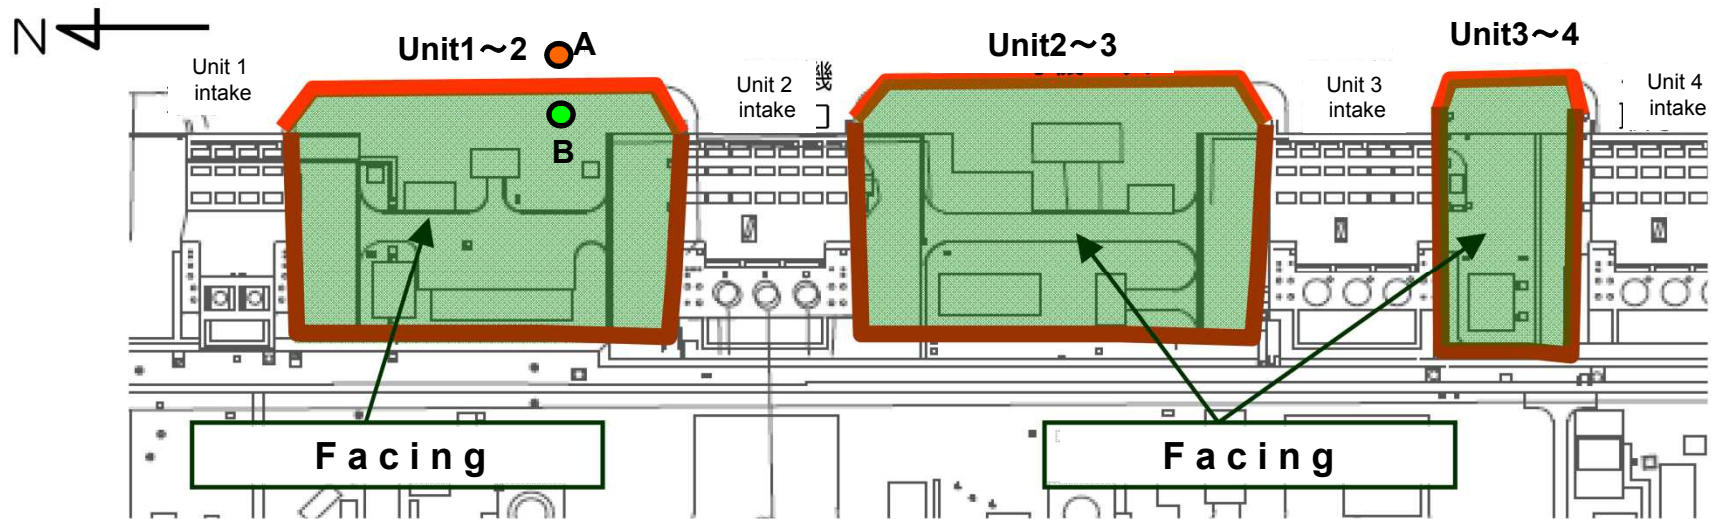
✓ Sealing Wall and Facing embracing contaminated water is under construction.

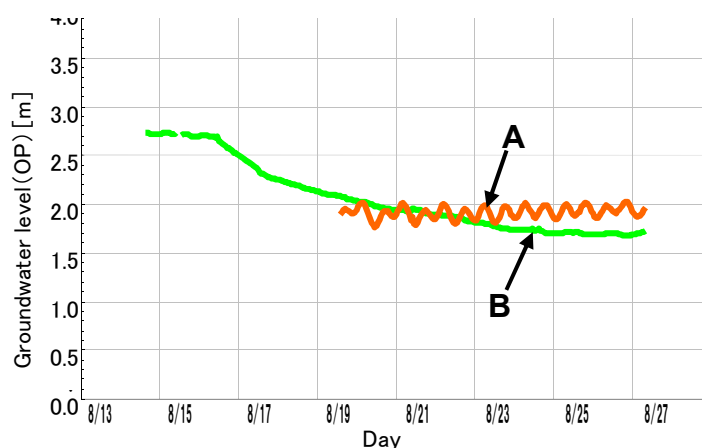
Groundwater Level inside the wall is lower than outside.
